Tree Survey Report

Site Ballymahon Road/Garden Vale

Date July 2011

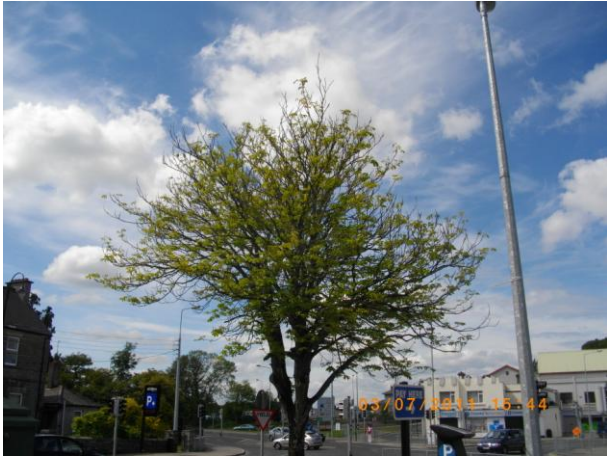
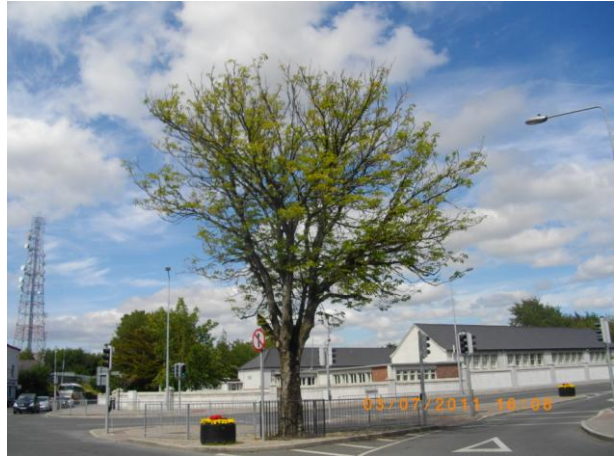
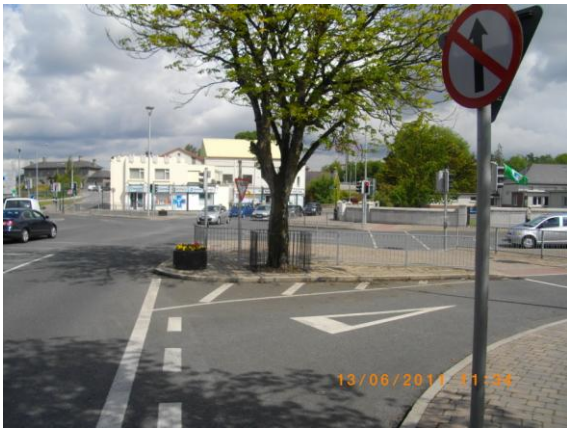
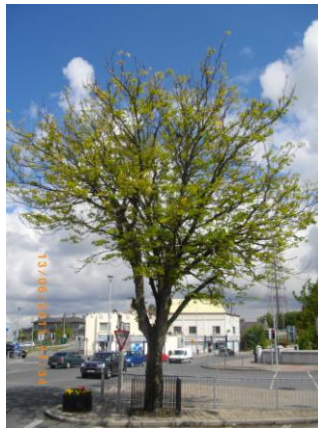
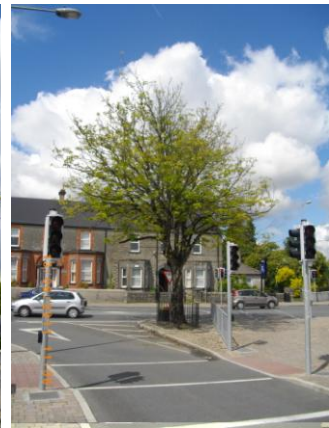
Recommendation 1 – T1

Due in line to the roads re-design trees T1 and T2, have been subject to root damage, as seen with the die back within the trees canopy (please see attached images – Appendix 3). Tree T3, is that of a mature Common Horse Chestnut (*Aesculus hippocastanum*), regrettable the nature of this species of trees does not take well to any sudden changes, and additionally due to their habit, they can be very prone to entry of decaying pathogen's. At the time of inspection it was noted that a large majority of the trees canopy was shutting down, and dying slowly, which leads to weak branches that have potentially in that location to cause serve harm. Should a failure occur there is potential to injury or damage, both pedestrians, but also property such as cars, etc

Tree T1, be removed within the next 12 months, and a suitable replacement be planted given the location, and of reasonable size.

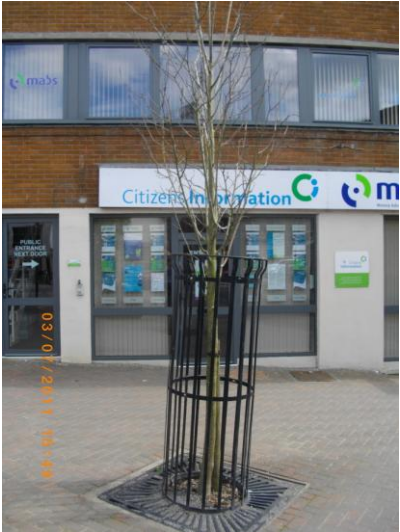
T8 – Dead

Tree T8, be removed and a suitable replacement species be planted. Tree T7, also be subject to formative pruning, to remove the epicormic growth, and loosen the tree tie if required, additionally removal of the cages is suggested as they add to the street furniture and form no real benefit in this setting.
